# Manhole Inspection Summary

Manhole # S67U\_\_014MH

Insp Date: **3/13/08 2:33 PM**

**Location** Address: **1700 Charlotte Ave.**

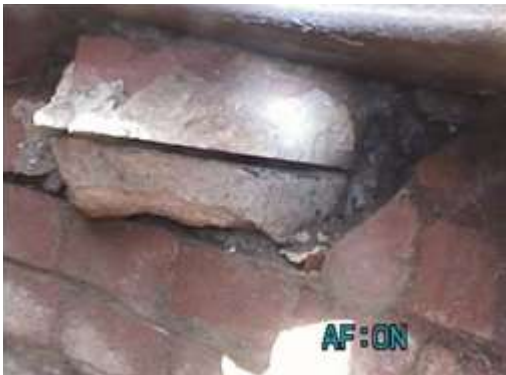
Defect 1

Condition: ☐ Sound ☐ Cracked ☐ Root Intrusion ☒ **Loose Brick** ☐ Deteriorated

Infiltration: ☐ None ☒ **Joint** ☐ Cracks ☐ Mortar ☐ Roots ☐ Wall

Loose bricks in chimney and sign of infiltration.

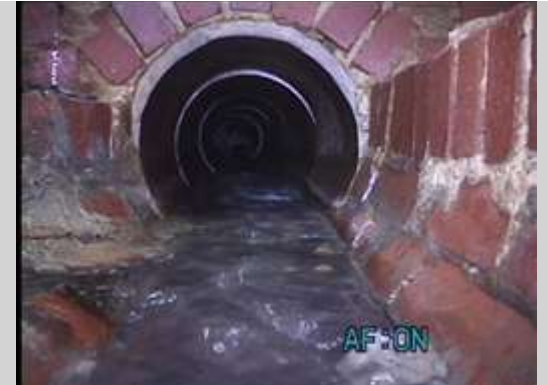
12 O'Clock Outflow

12 in. Circular Gravity Sewer  
Pipe Out @ 12 O'Clock

Pipe Height: **12** (in.) Rod and Bar (Angled)  
Pipe Material: **Clay** ☐ Pipe Lined  
Invert Depth: **8.33** (ft.) Flow Characteristics: **Fast**  
Deposits: ☒ None ☐ Mud ☐ Sludge ☐ Debris ☐ Grease  
Silt Depth: (in.) Deposits Extent:  
Infiltration: **None** Pipe Seal Cond: **Sound**

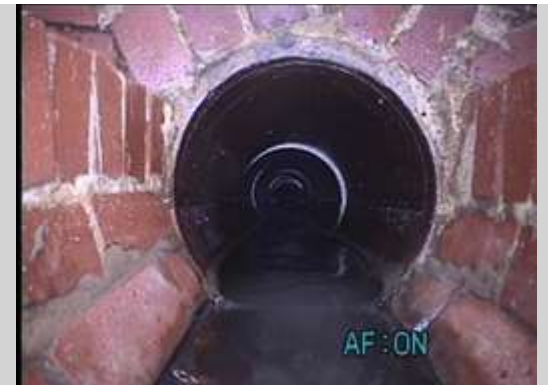
6 O'Clock Inflow

10 in. Circular Gravity Sewer  
Pipe In @ 6 O'Clock

Pipe Height: **10.8** (in.) Rod and Bar (Angled)  
Pipe Material: **Clay** ☐ Pipe Lined  
Invert Depth: **8.08** (ft.) Flow Characteristics: **Fast**  
Deposits: ☒ None ☐ Mud ☐ Sludge ☐ Debris ☐ Grease  
Silt Depth: (in.) Deposits Extent:  
Infiltration: **None** Pipe Seal Cond: **Sound**

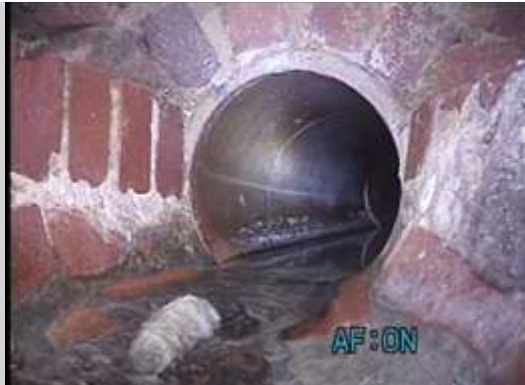
9 O'Clock Inflow

8 in. Circular Gravity Sewer

Pipe In @ 9 O'Clock

Pipe Height: **8.4** (in.) Rod and Bar (Angled)

Invert Depth: **8.00** (ft.) Flow Characteristics: **Slow**

Infiltration: **None** Pipe Seal Cond: **Sound**
